A GREEN INFRASTRUCTURE CASE STUDY

On-farm green infrastructure to reduce sediment
accumulation in Municipal Drain

Case Study: On-farm Green Infrastructure to reduce sediment accumulation in Municipal Drain

Drain: McFadyen Drain

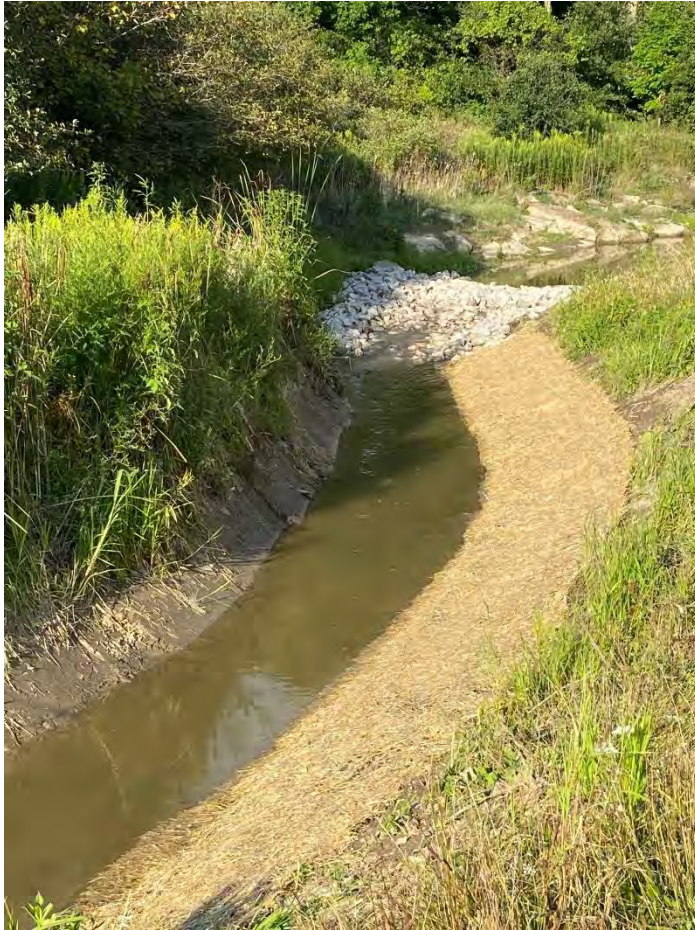
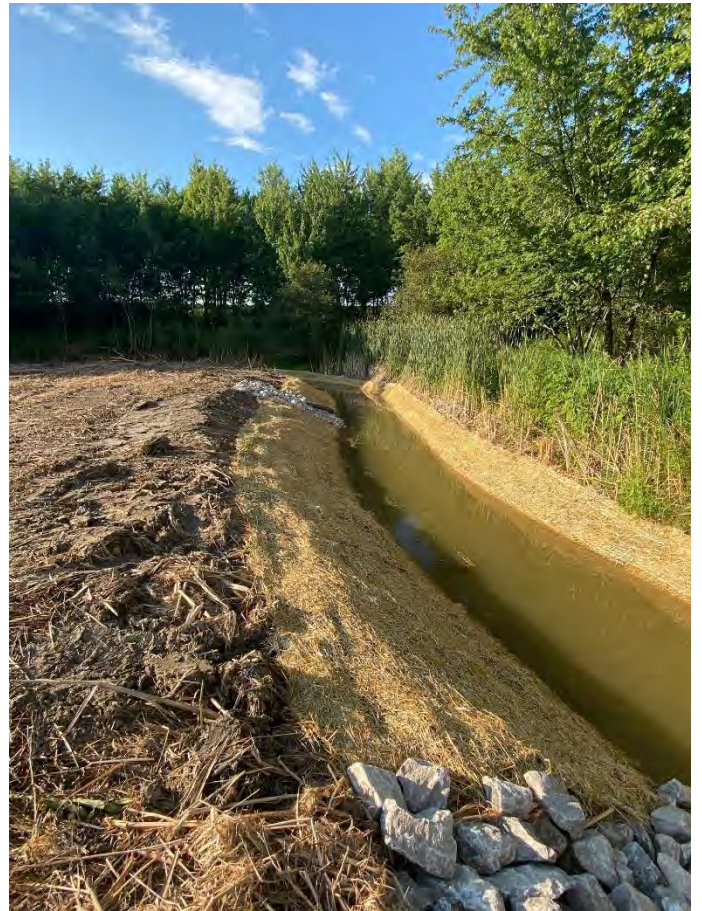
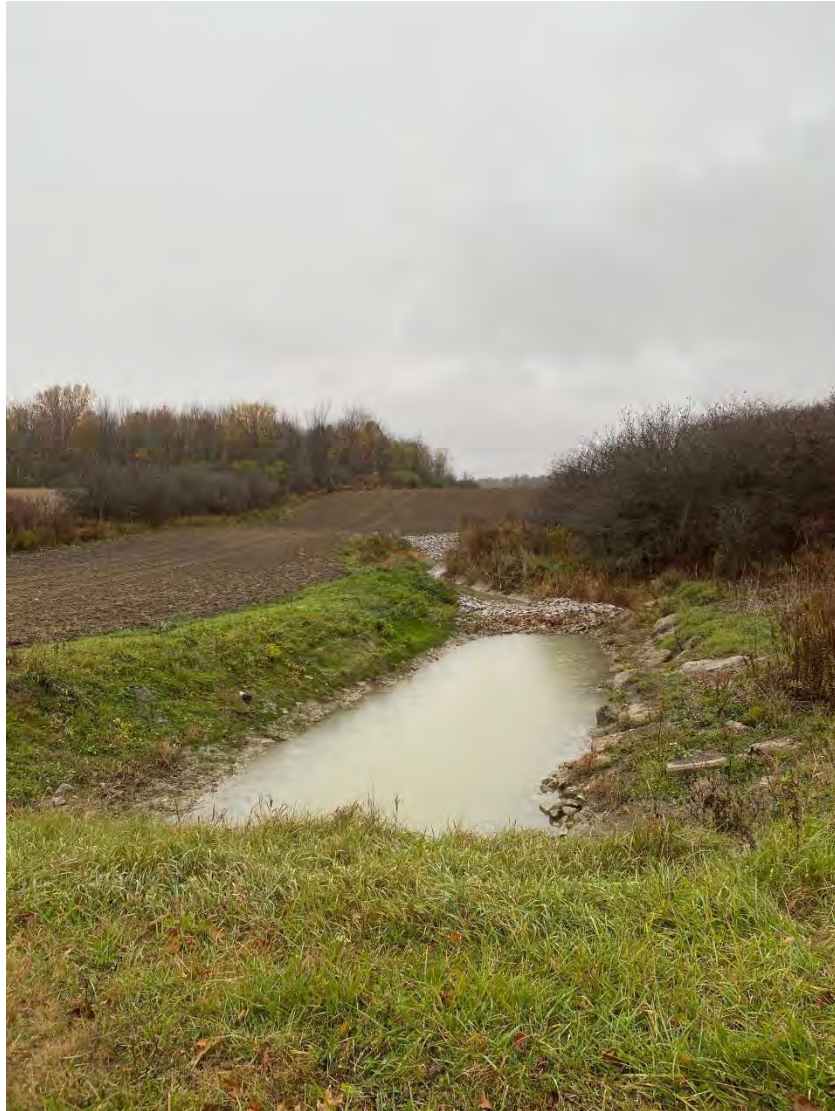
Photos:

Best Management Practice: One sediment trap complete with rock check dam, 8 rock chutes and erosion control matting.

Issue: Request for repair on the McFadyen drain was made by affected landowners as the velocity of water moving downstream of Tile Yard Rd was causing erosion and washouts of the natural meanders in the channel and exposing subsurface tile drains.

Sediment trap with rock check dam: rock check dam designed as per specifications in the Department of Fisheries and Oceans Guidance for Maintaining and Repairing Municipal Drains in Ontario, the rock check dam is designed to slow water down as it moves downstream in order to protect the natural meanders. The sediment trap is designed to filter out and hold the fine sediments as it moves through the check dam. These two features work together to reduce erosion and sediment movement downstream.

Rock chutes: Build rock chutes at 8 locations along the drain within the side slope. The rock chutes will provide additional support to the drain banks by slowing overland flow entering the drain through low runs and reducing the sediment entering the system.
